PLANS FOR
IMPROVEMENT OF NAVIGATION CONDITIONS
IN
CORRAL BAY AND THE VALDIVIA RIVER, CHILE

HYDRAULIC MODEL INVESTIGATION

TECHNICAL MEMORANDUM NO. 2-382

WATERWAYS EXPERIMENT STATION
VICKSBURG, MISSISSIPPI

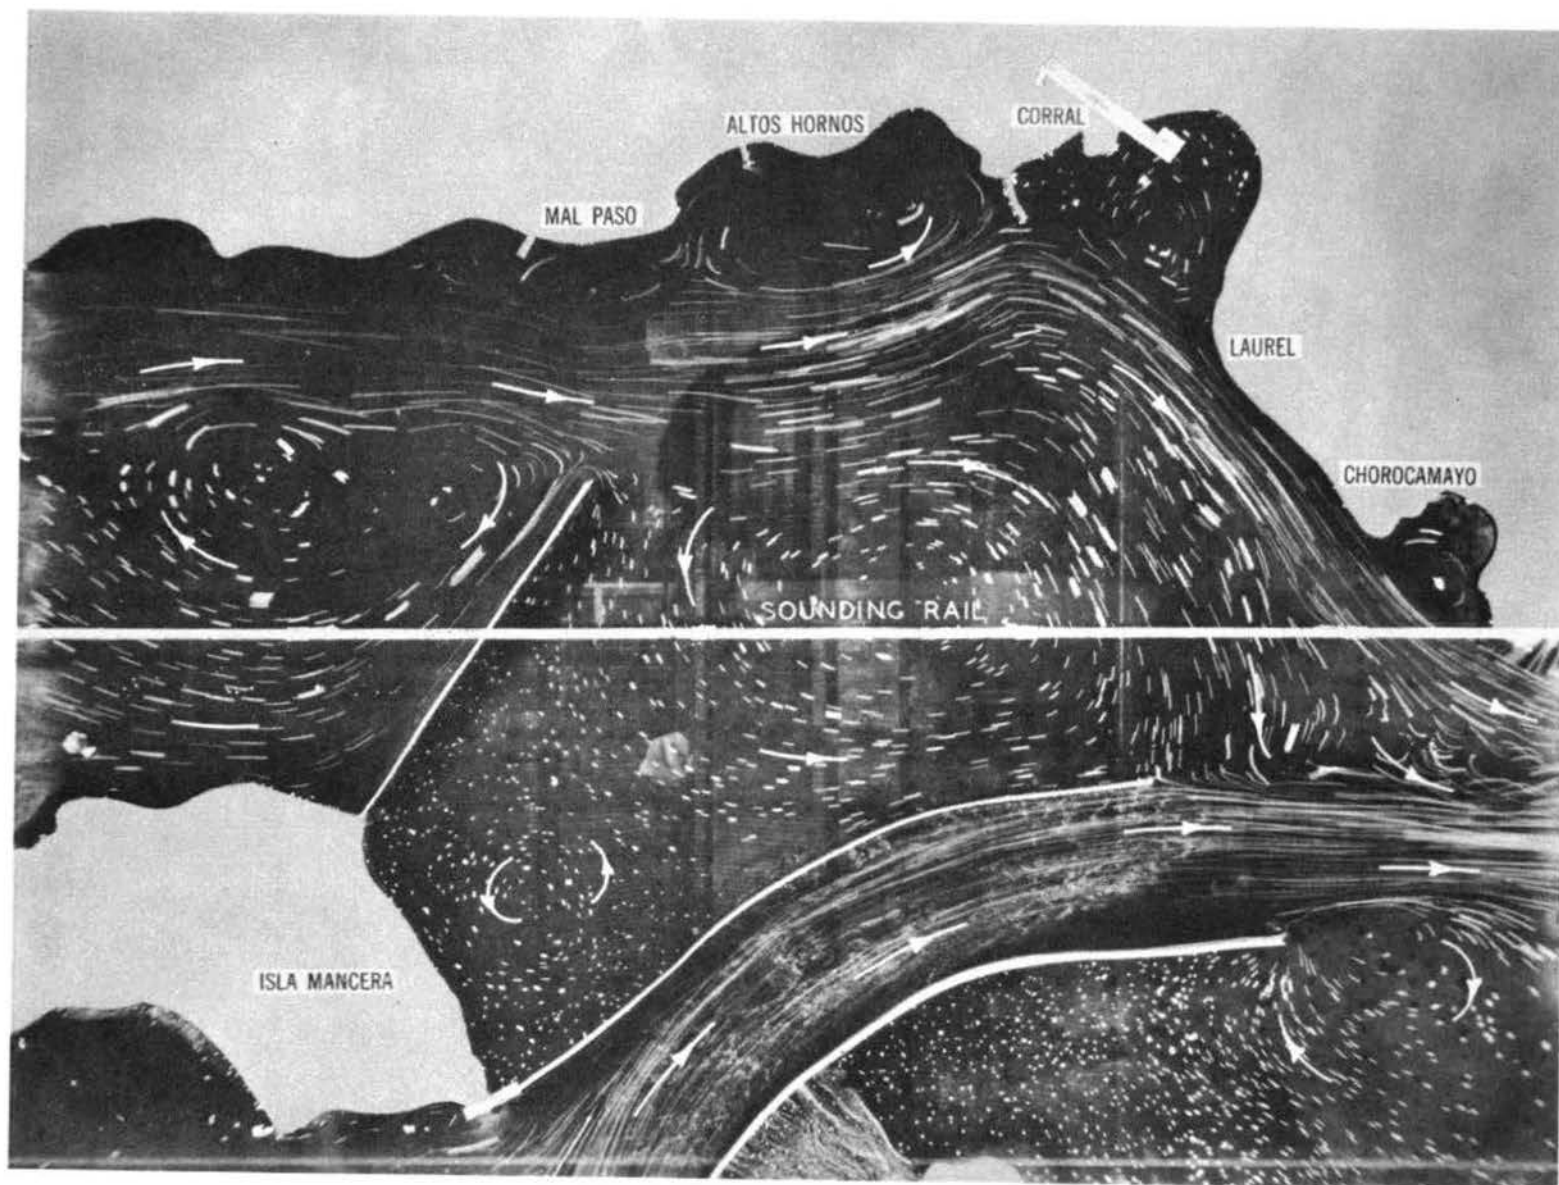
Photograph 10. Strength of ebb, plan 4

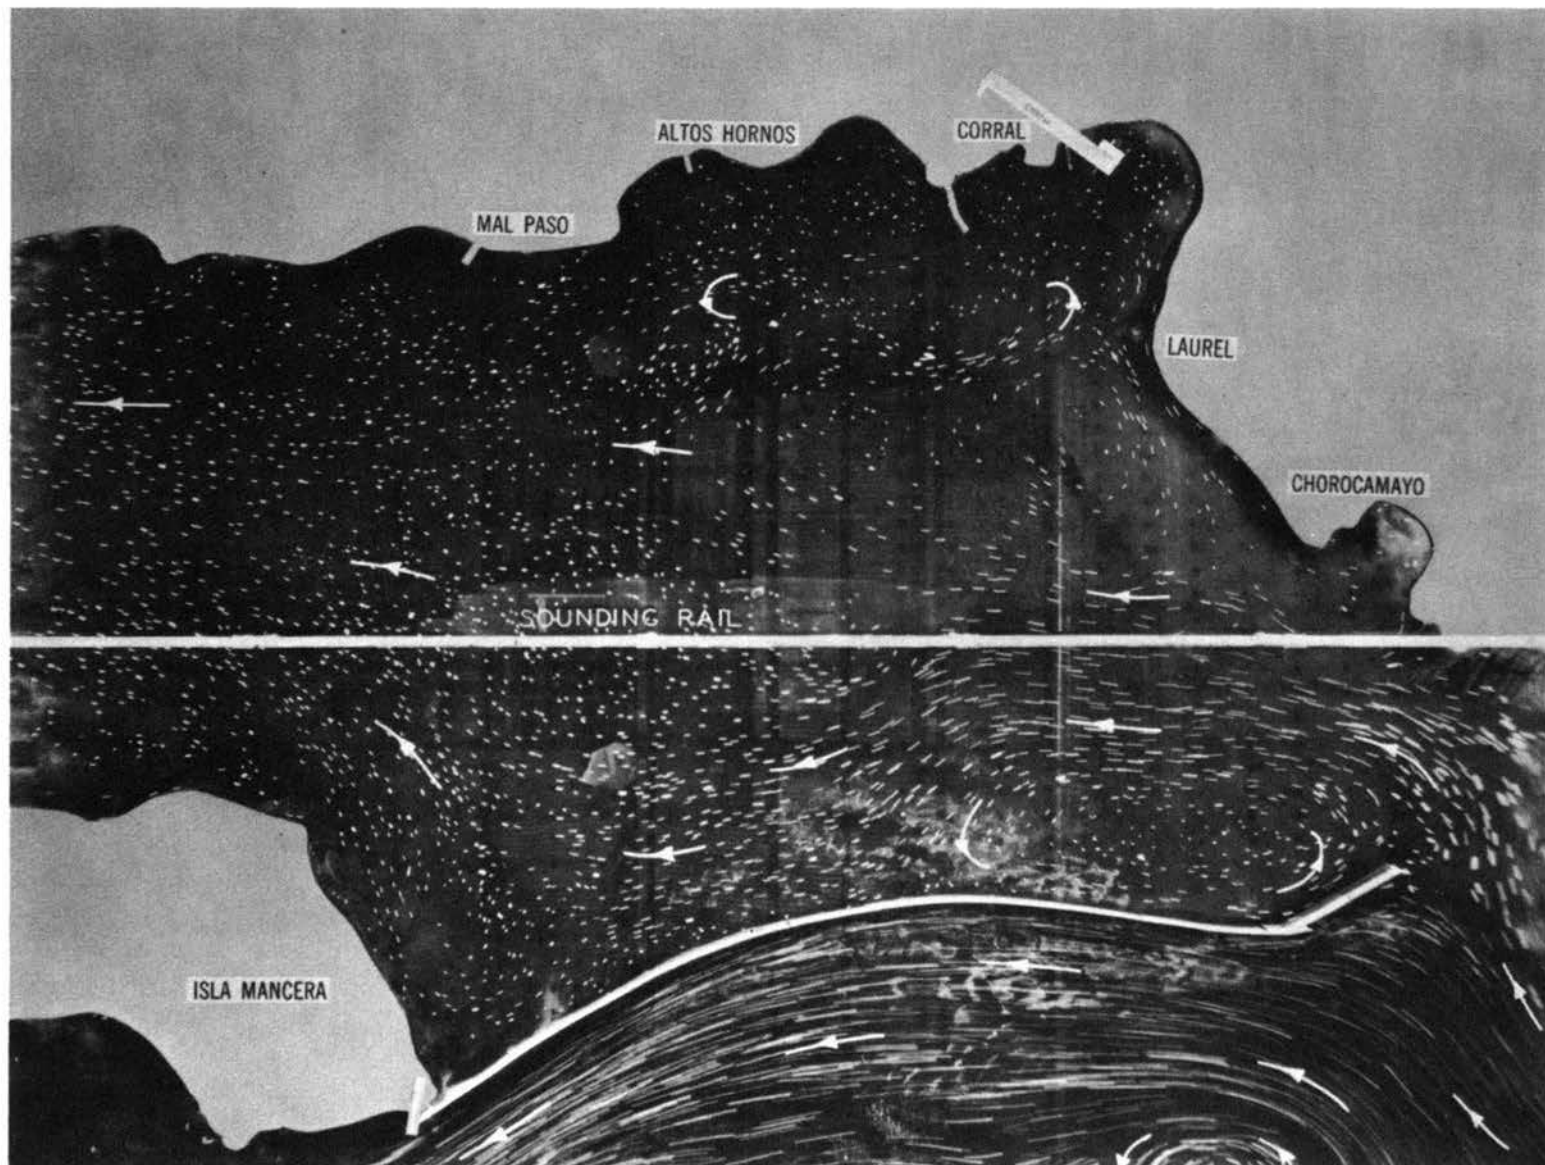
Photograph 11. Strength of flood, plan 5

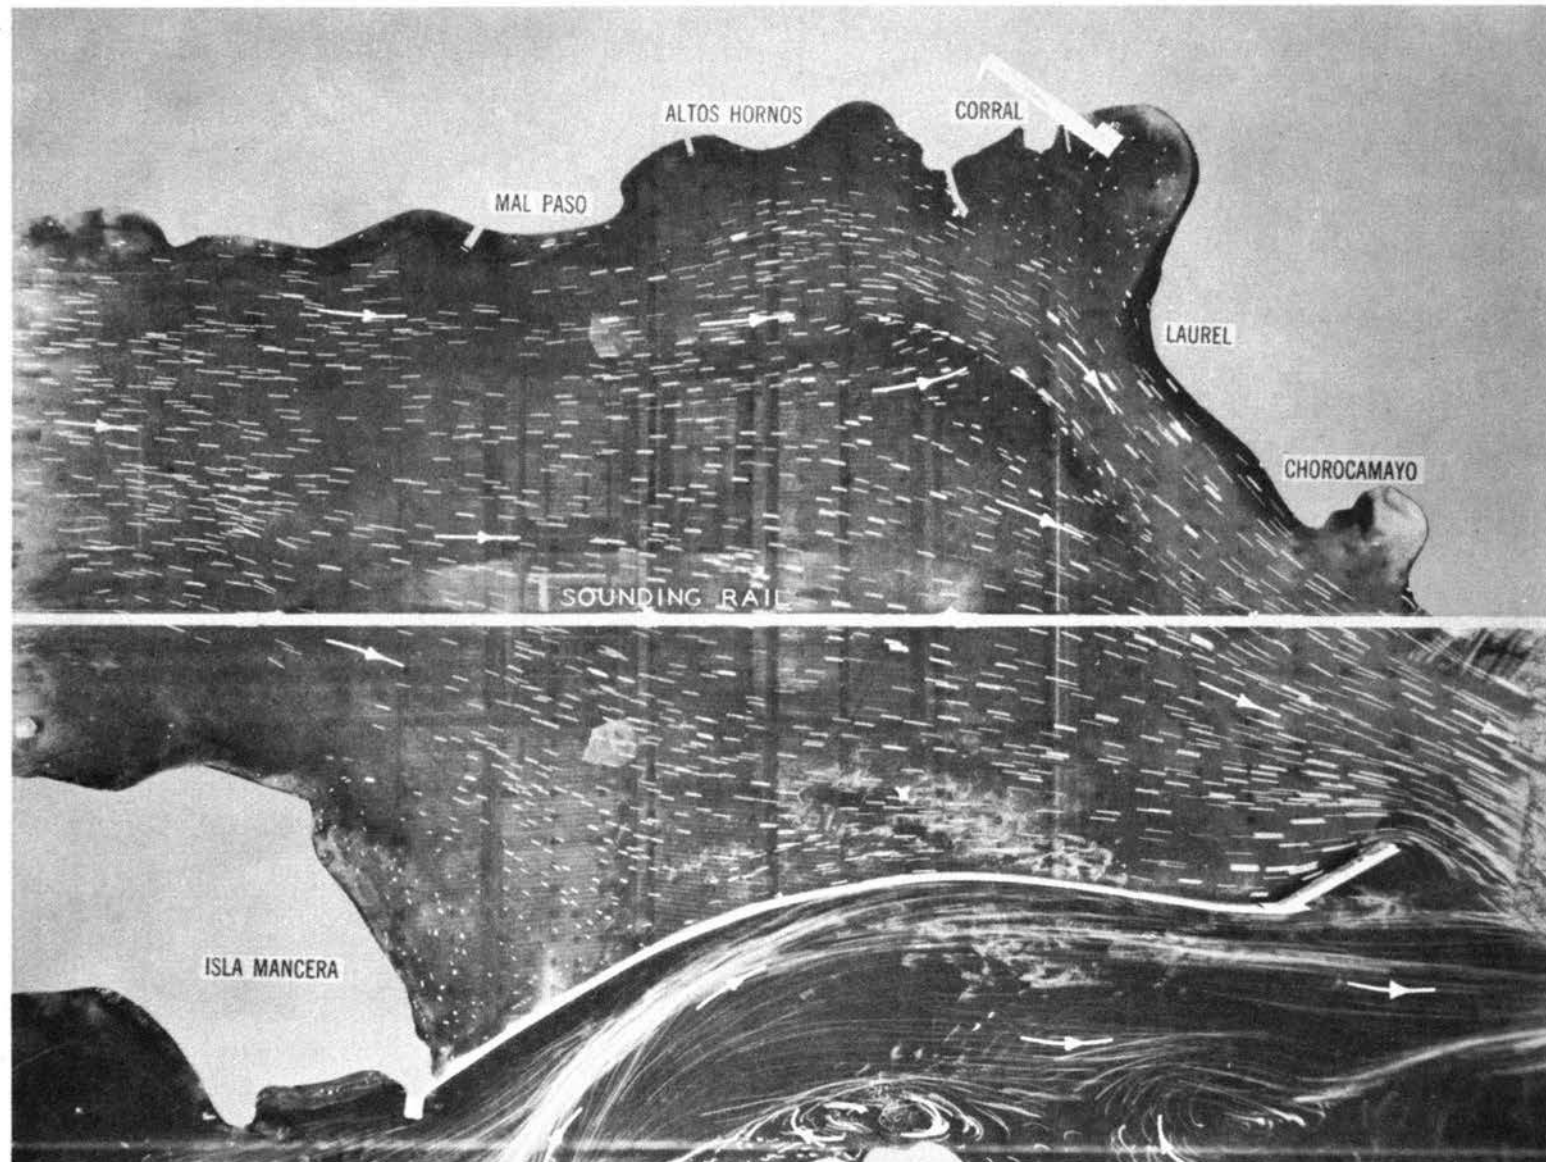
Photograph 12. Strength of ebb, plan 5

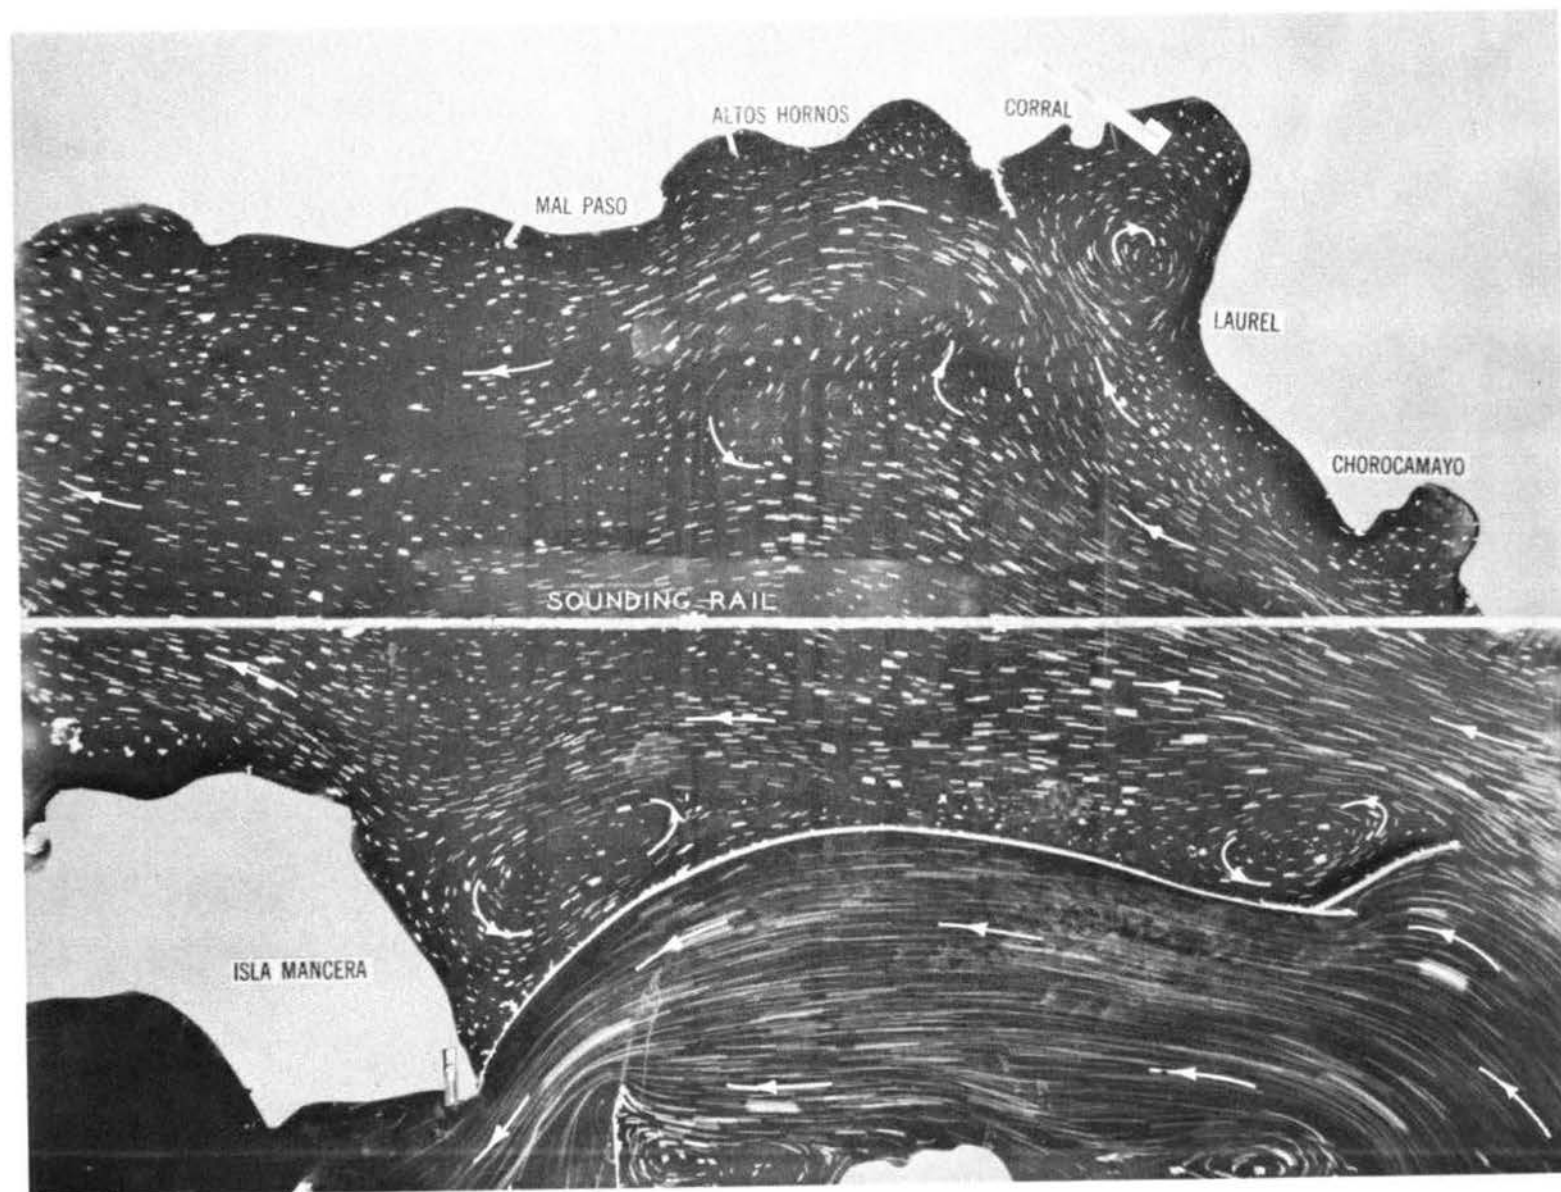
Photograph 13. Strength of flood, plan 6

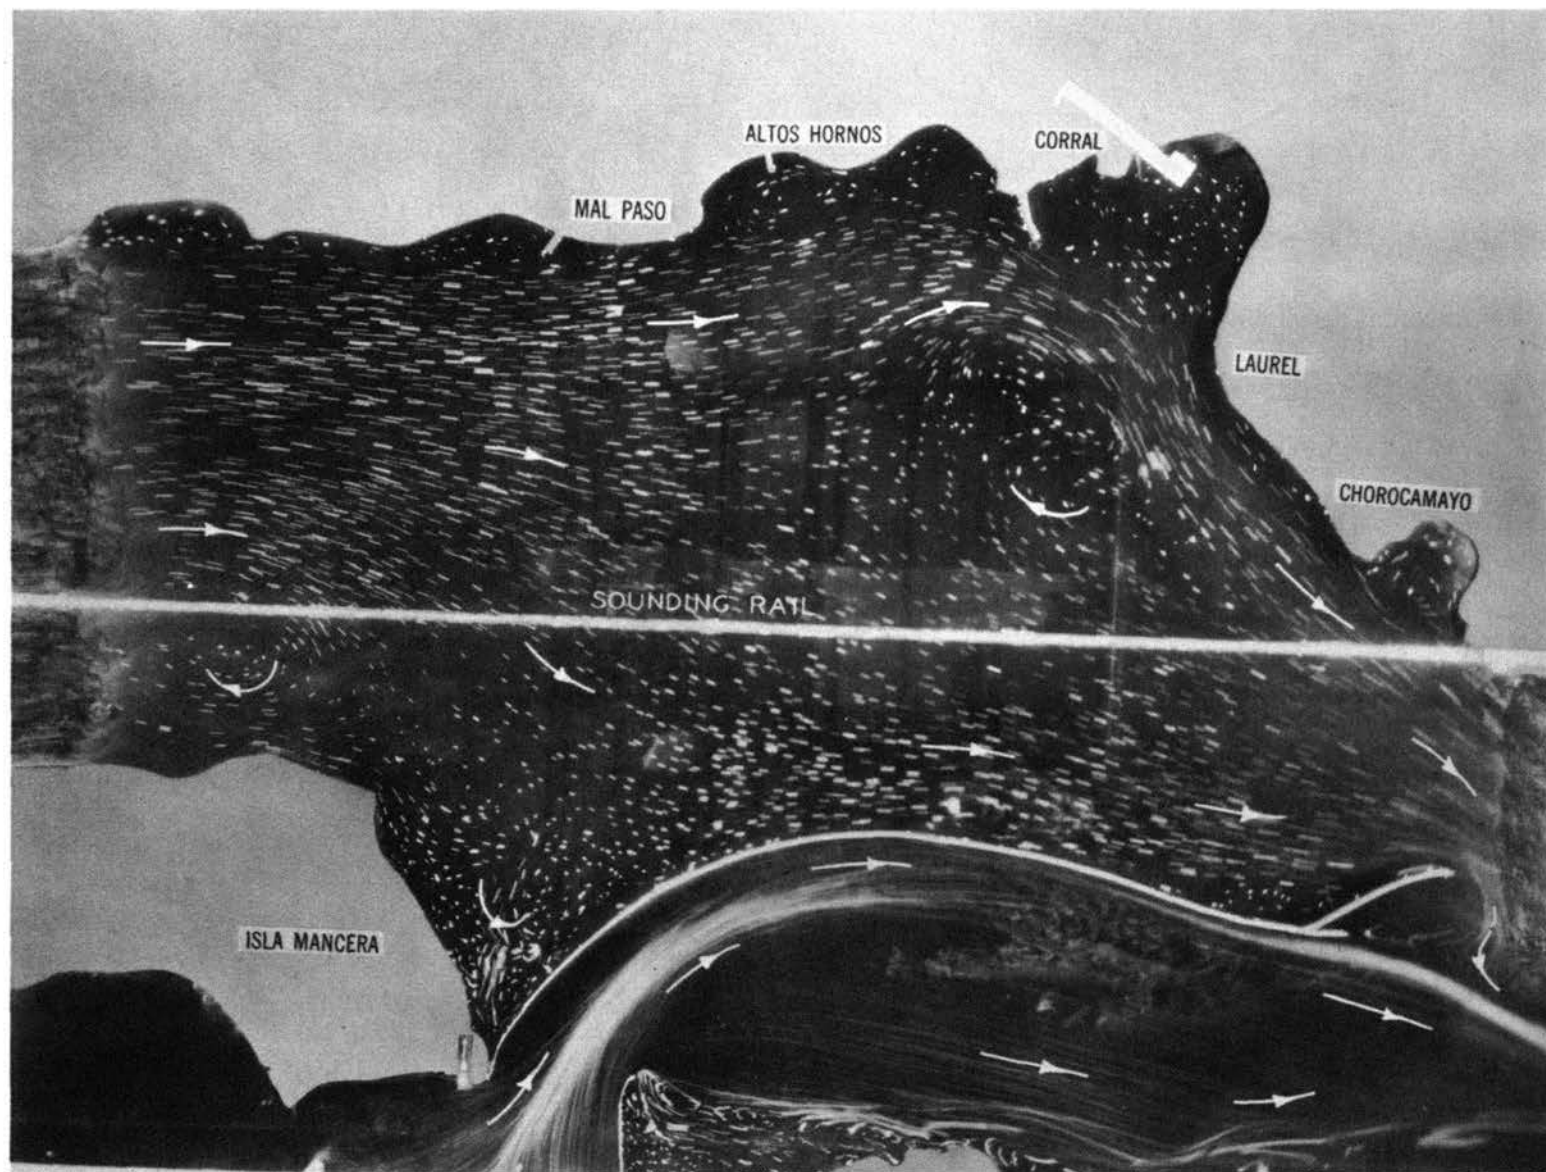
Photograph 14. Strength of ebb, plan 6

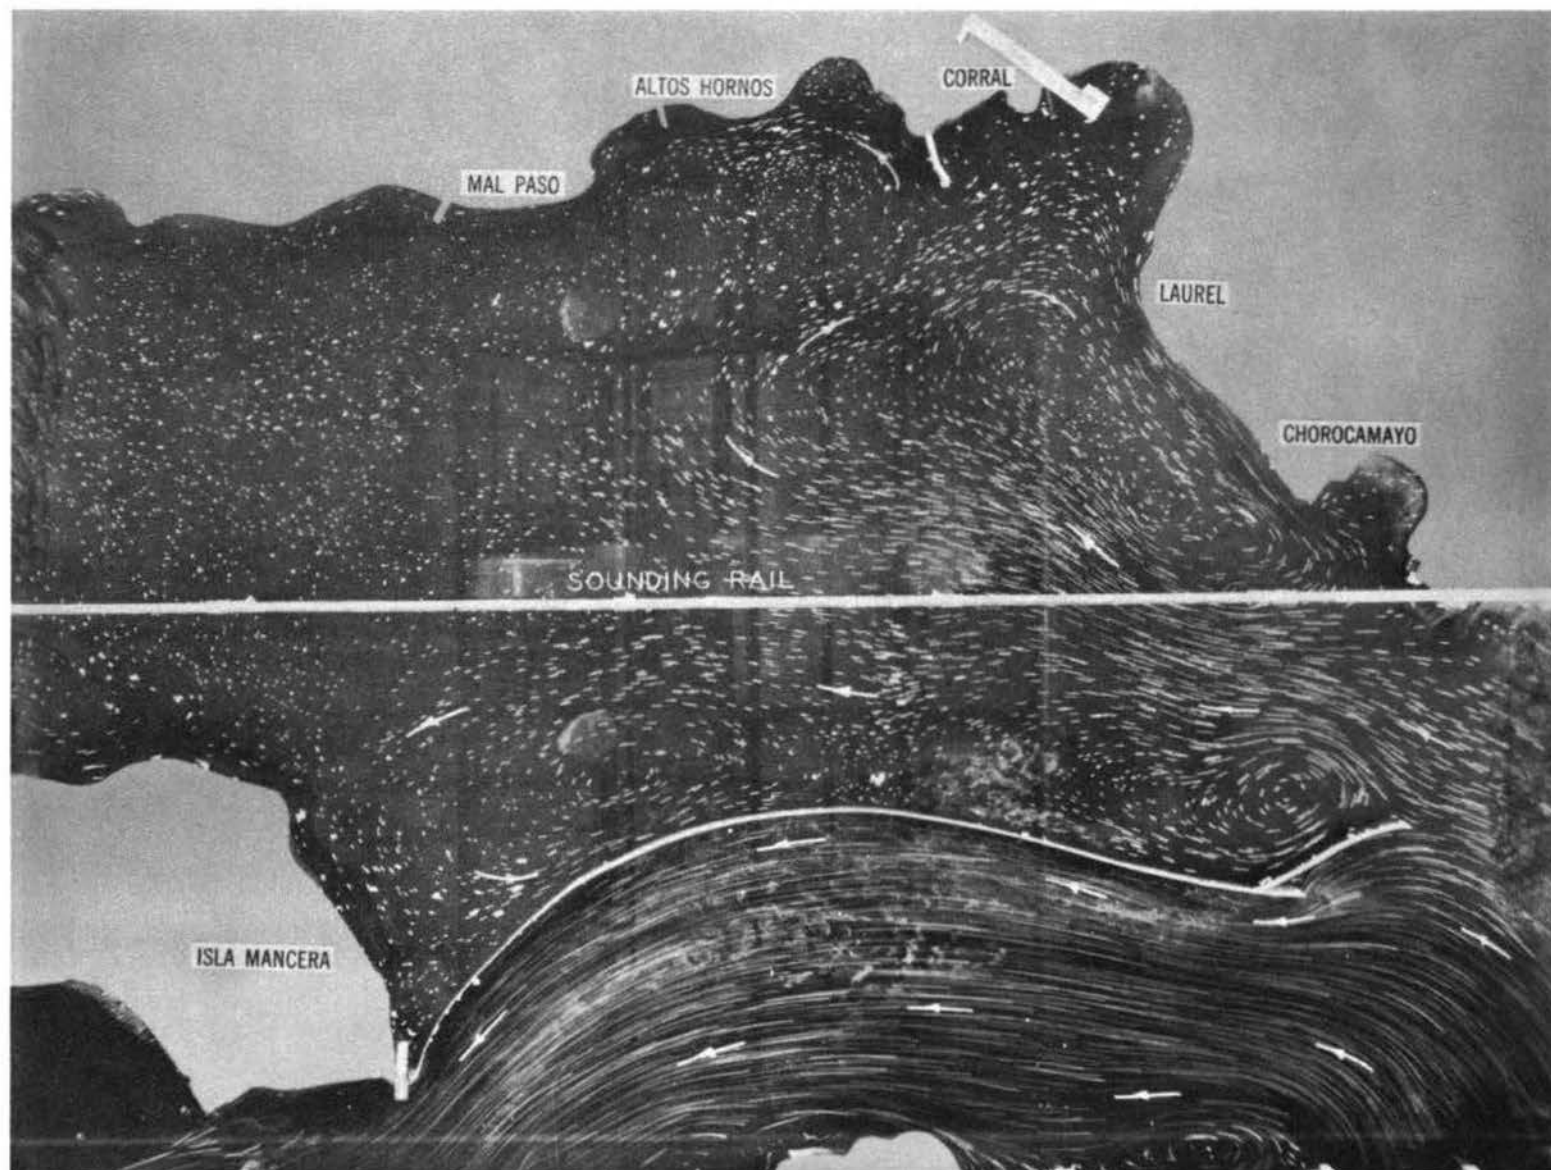
Photograph 15. Strength of flood, plan 7

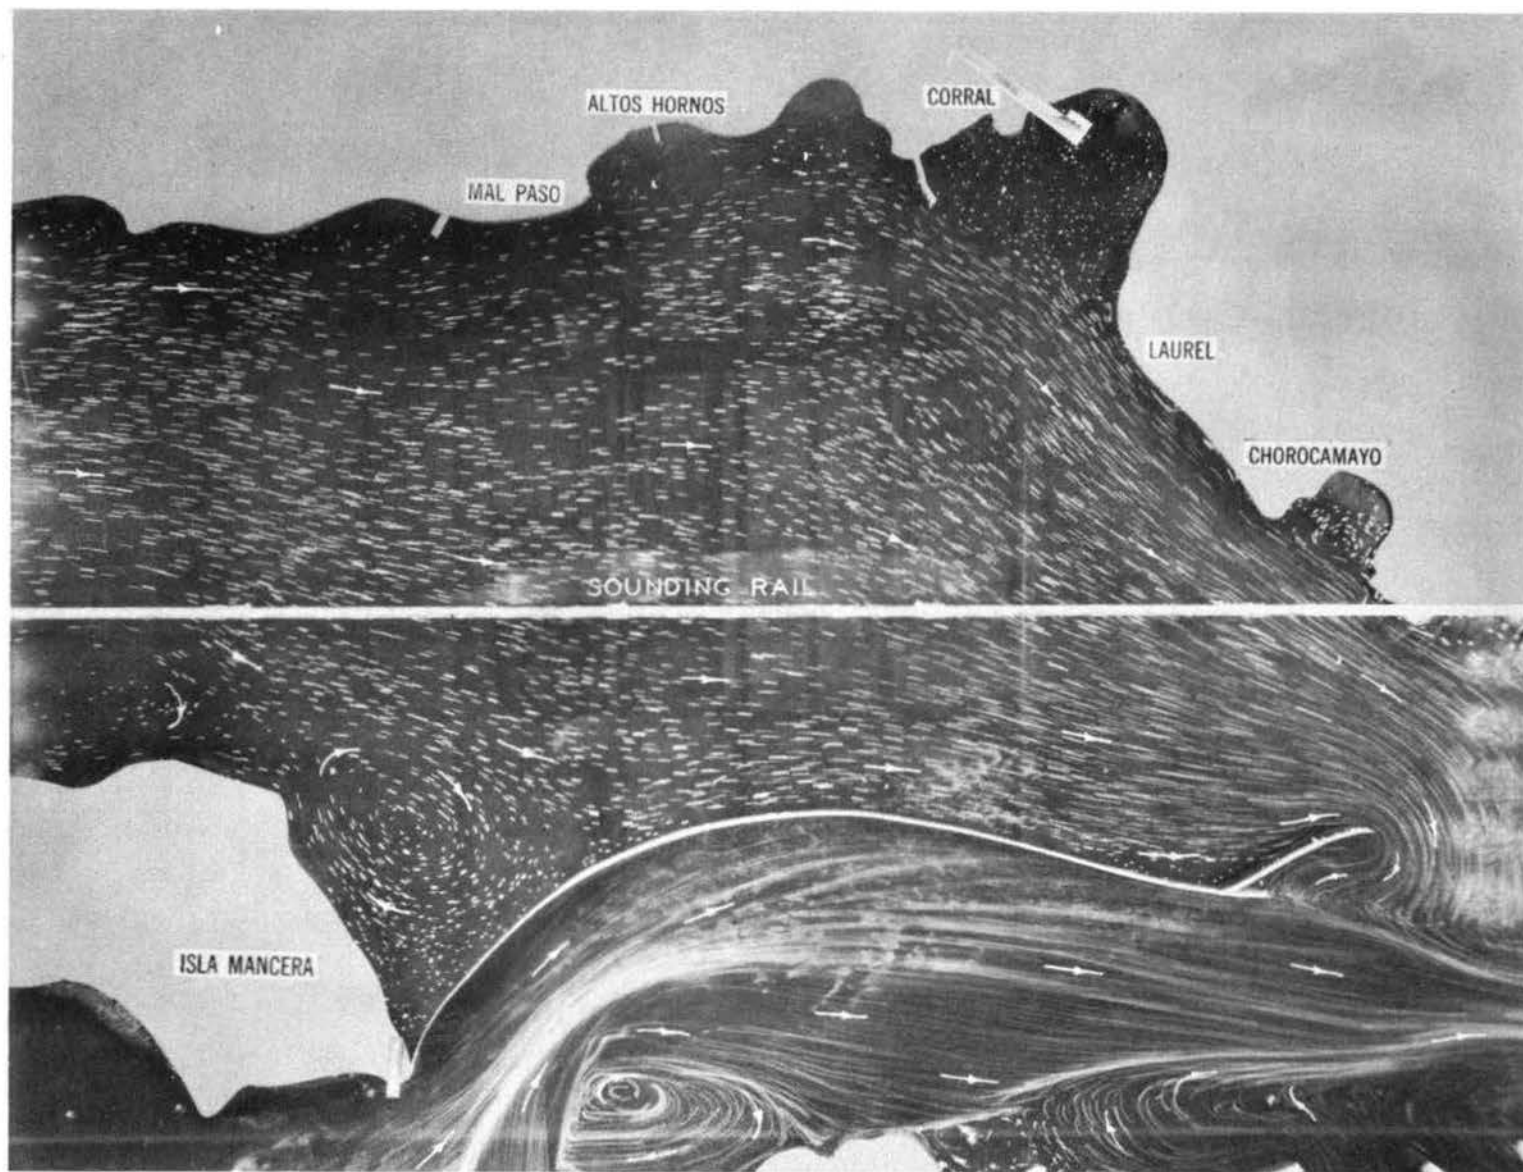
Photograph 16. Strength of ebb, plan 7

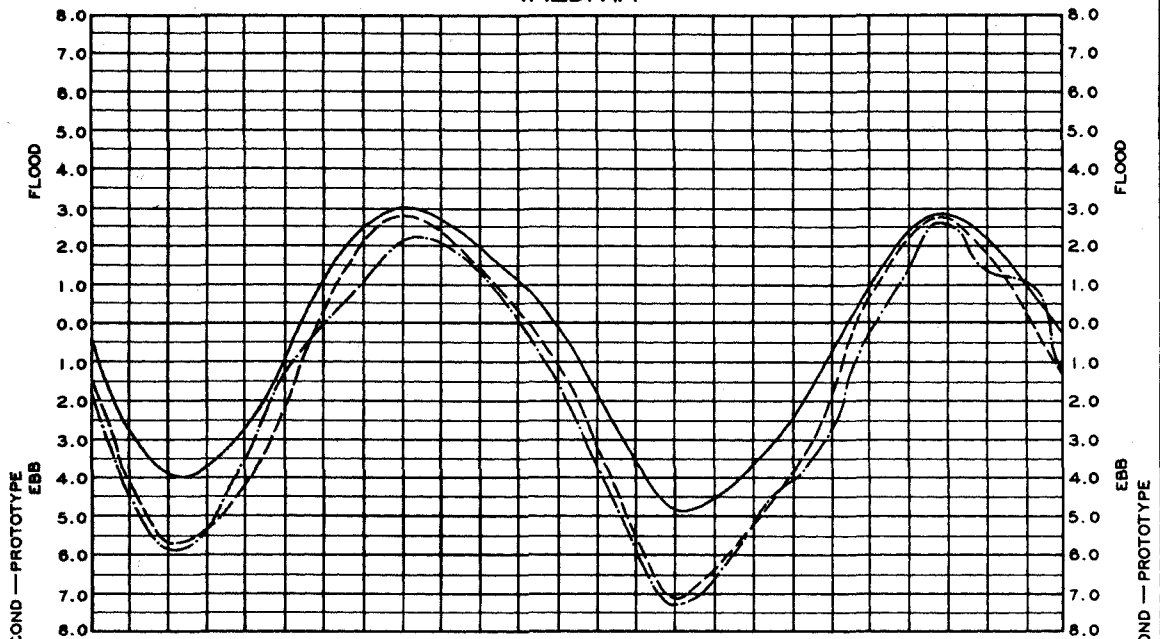
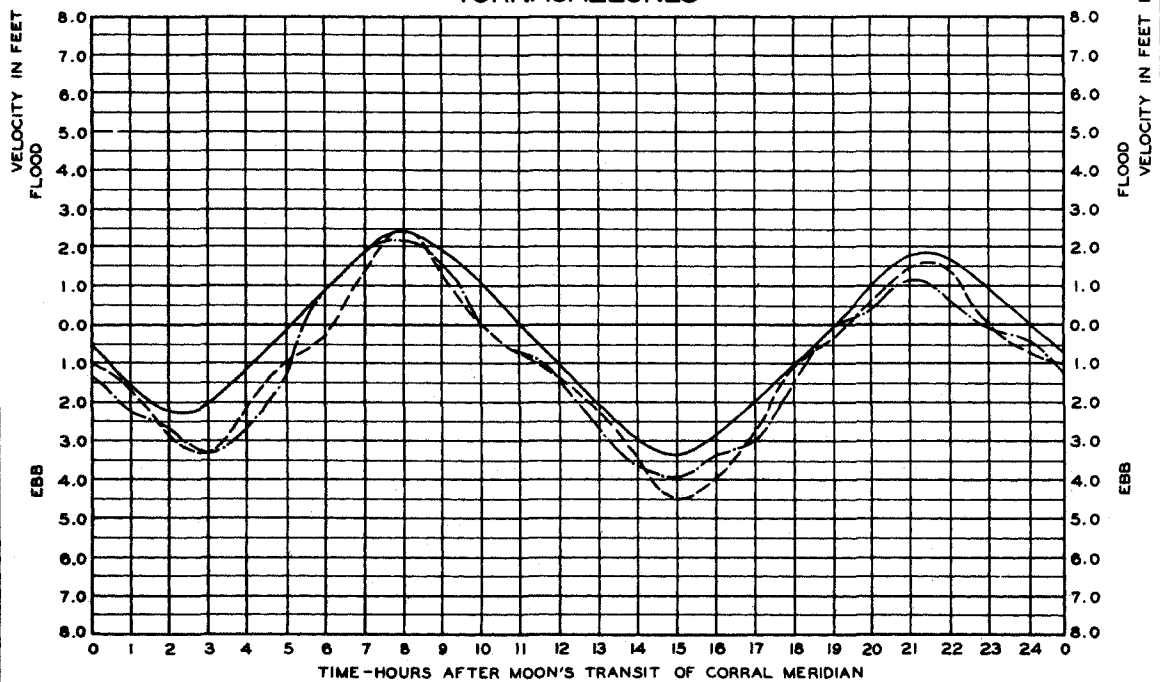
VELOCITY CURVES
VERIFICATION TEST

VALDIVIA

TORNAGALEONES

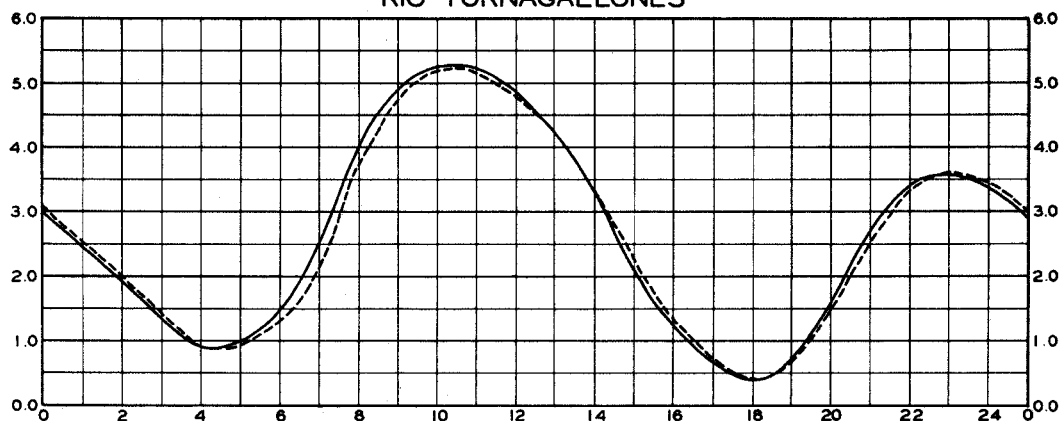
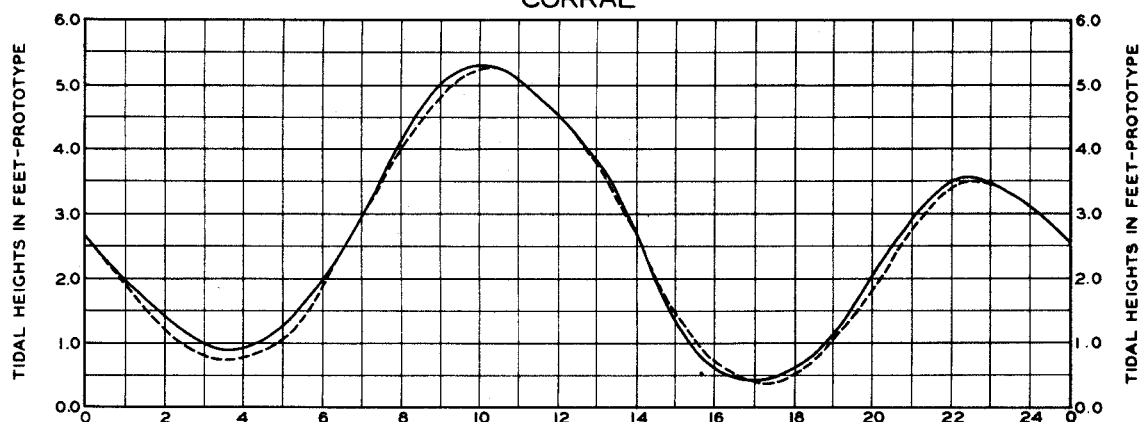
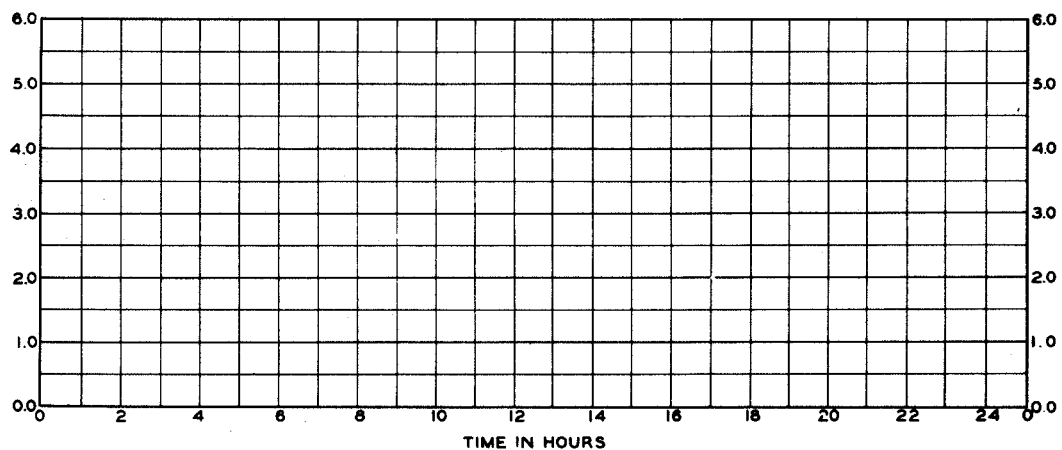
TIDE CURVES
PLAN I
LOS MOLINOS, MUELLE DE PASAJEROS
AND CANCAQUAL

RIO TORNAGALEONES

CORRAL

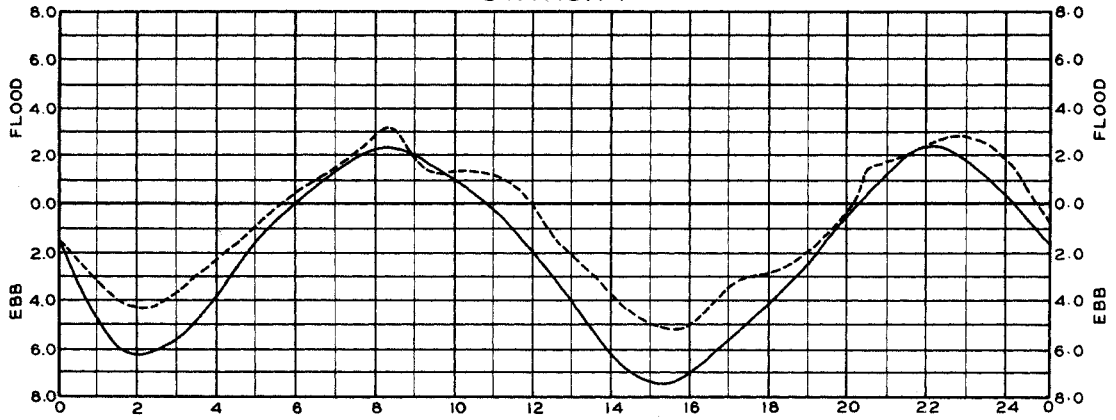
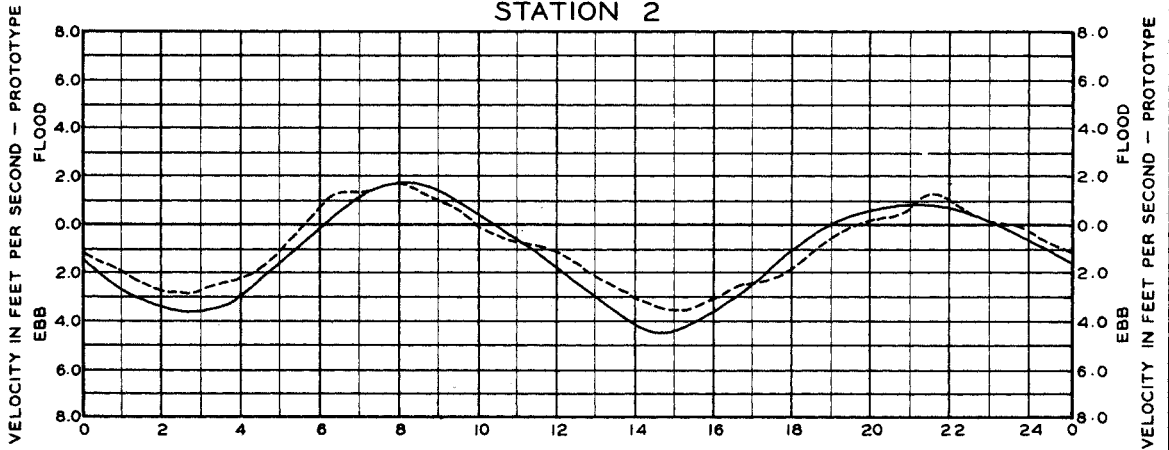
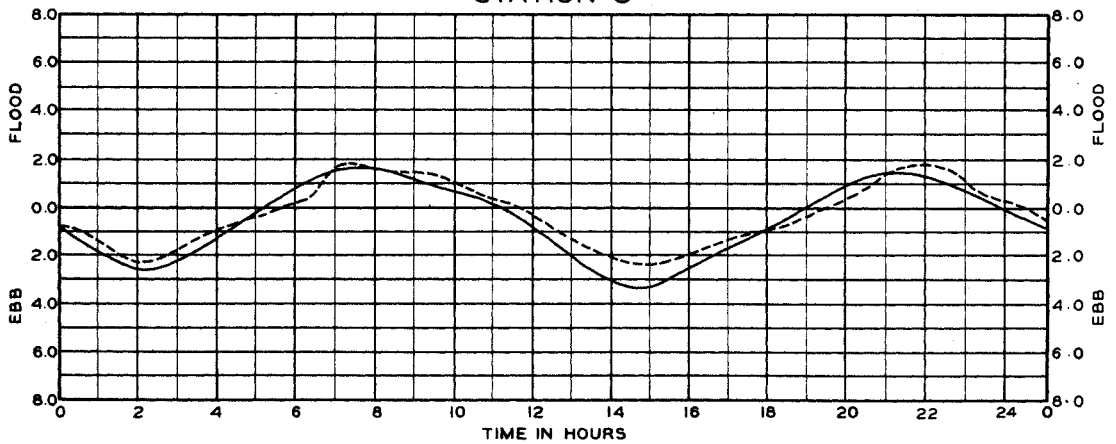
VELOCITY CURVES PLAN I STATIONS 1 TO 3

RIO TORNAGALEONES AND CORRAL

STATION 1

STATION 2

STATION 3

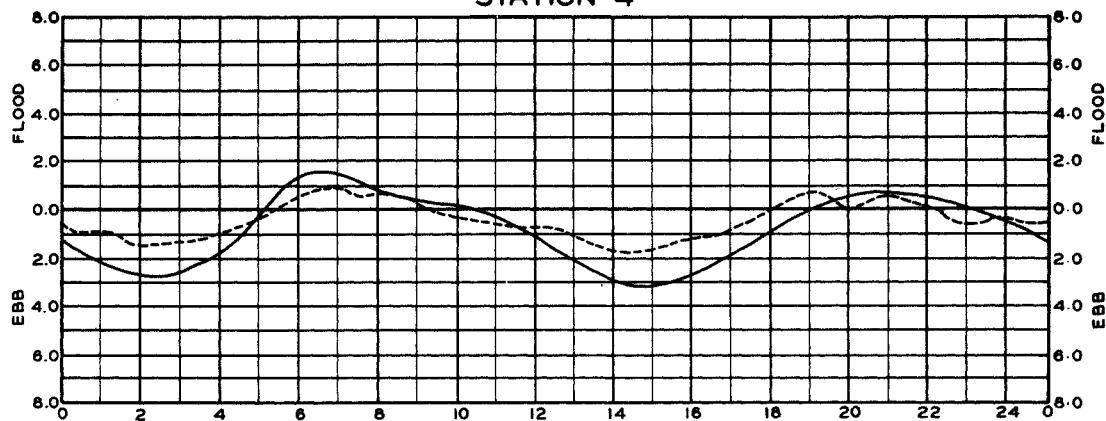
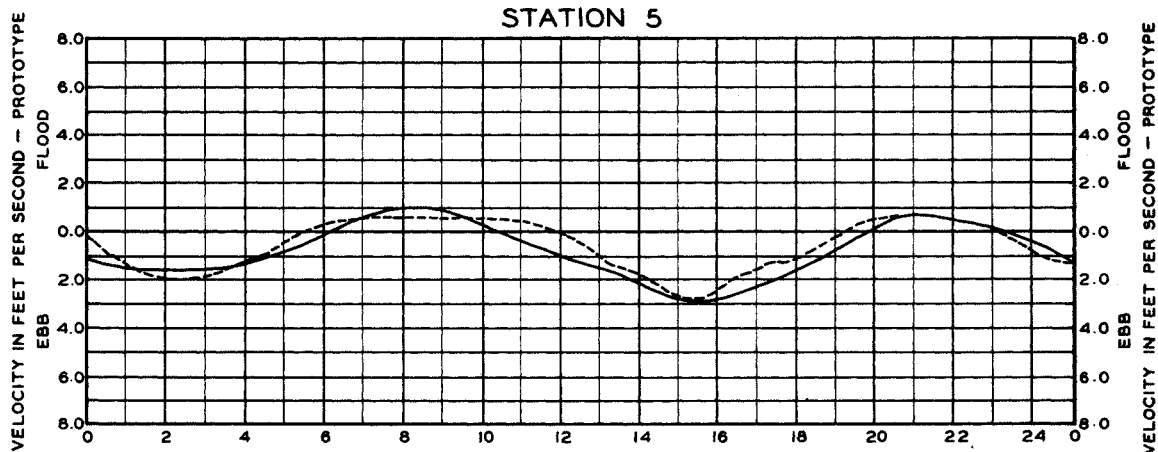
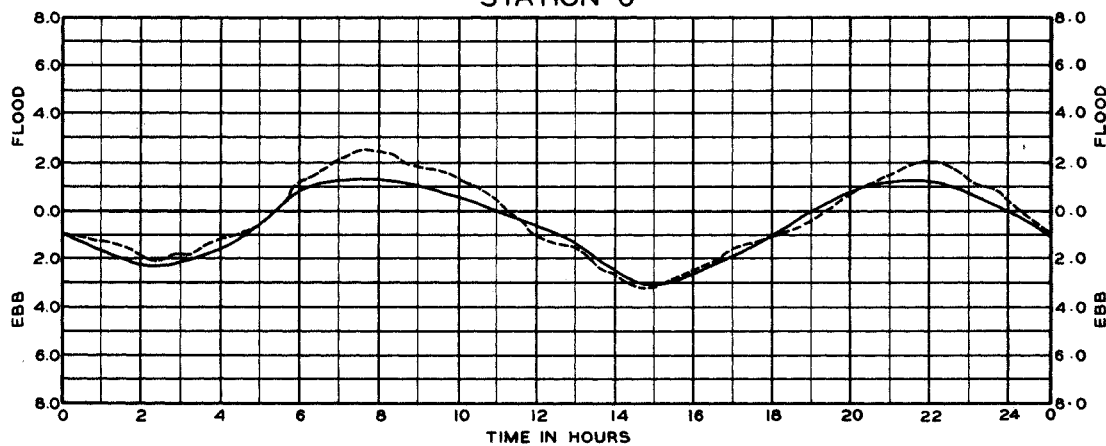
PLAN I

STATION 4

STATION 5

STATION 6

STATIONS 4 TO 6

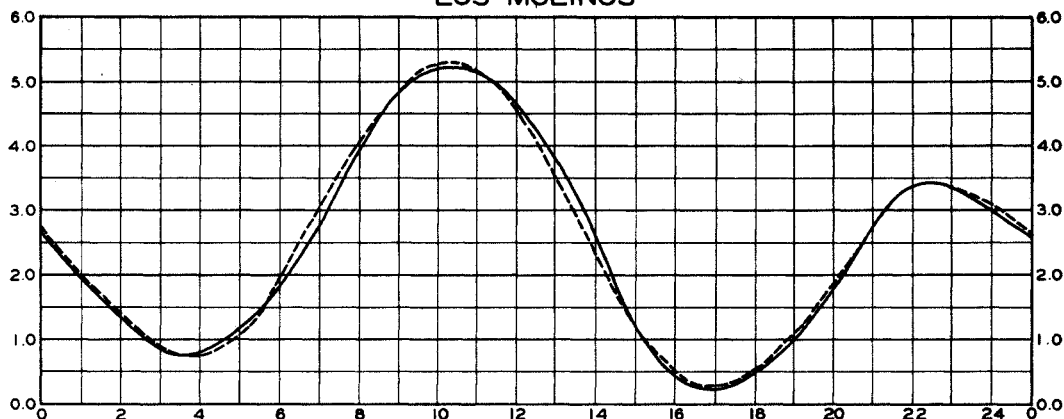
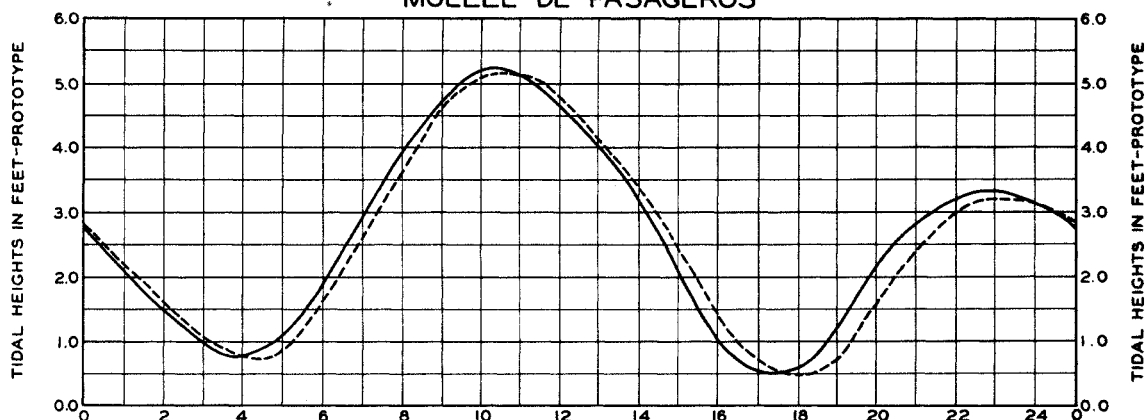
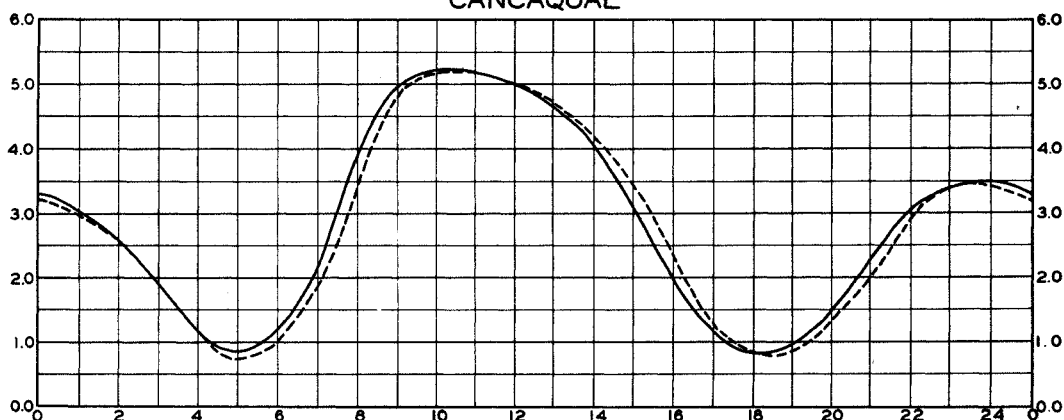
LOS MOLINOS

MUELLE DE PASAJEROS

CANCAQUAL

PLAN 2

LOS MOLINOS, MUELLE DE PASAJEROS
AND CANCAQUAL

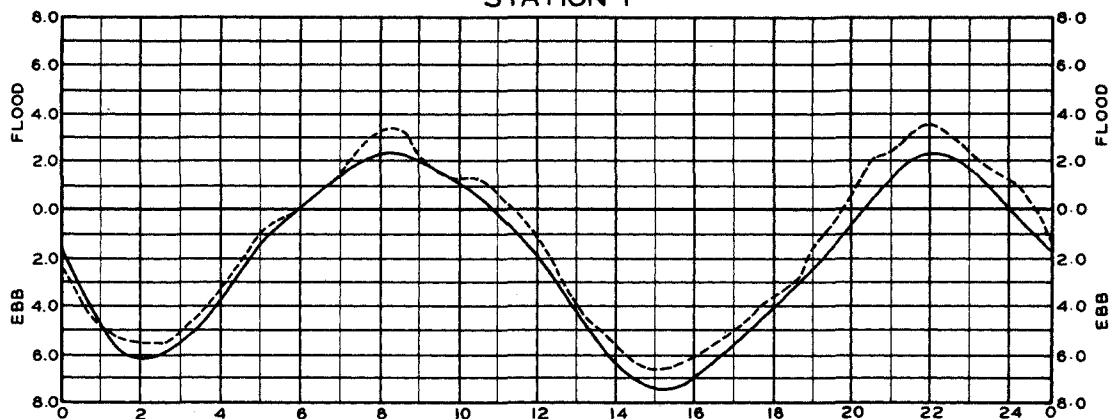
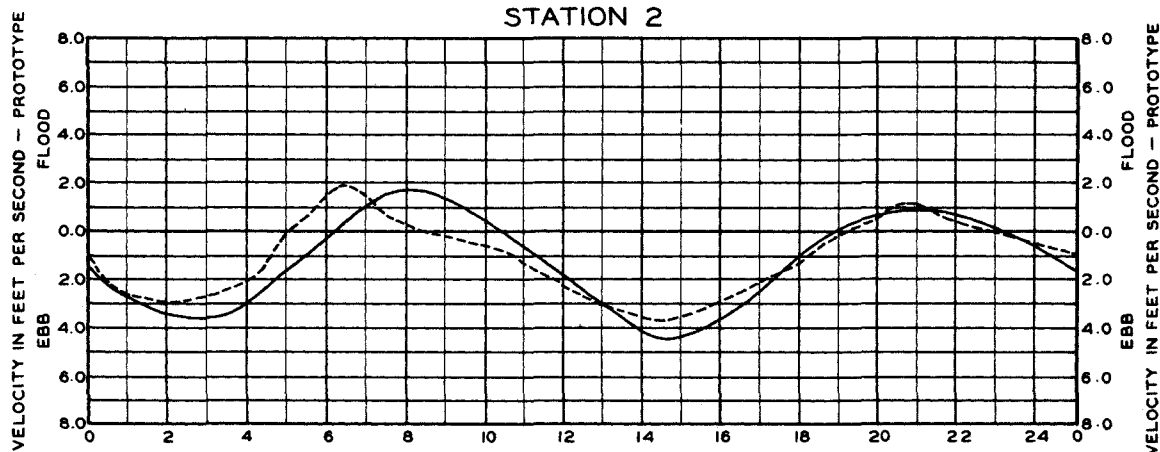
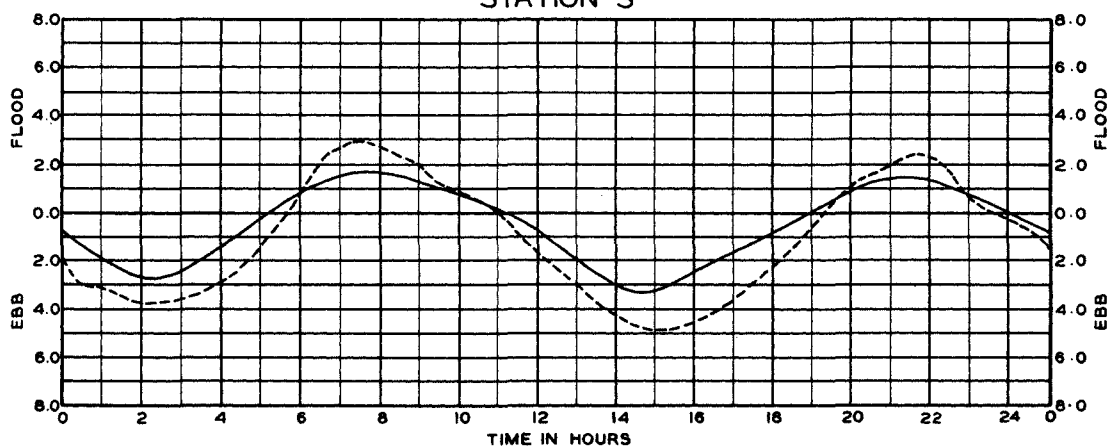
VELOCITY CURVES PLAN 2 STATIONS 1 TO 3

STATION 1

STATION 2

STATION 3

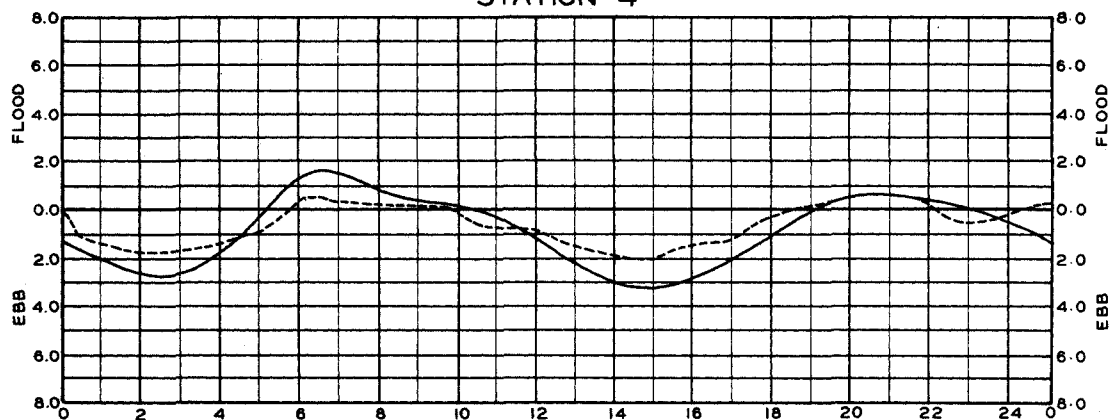
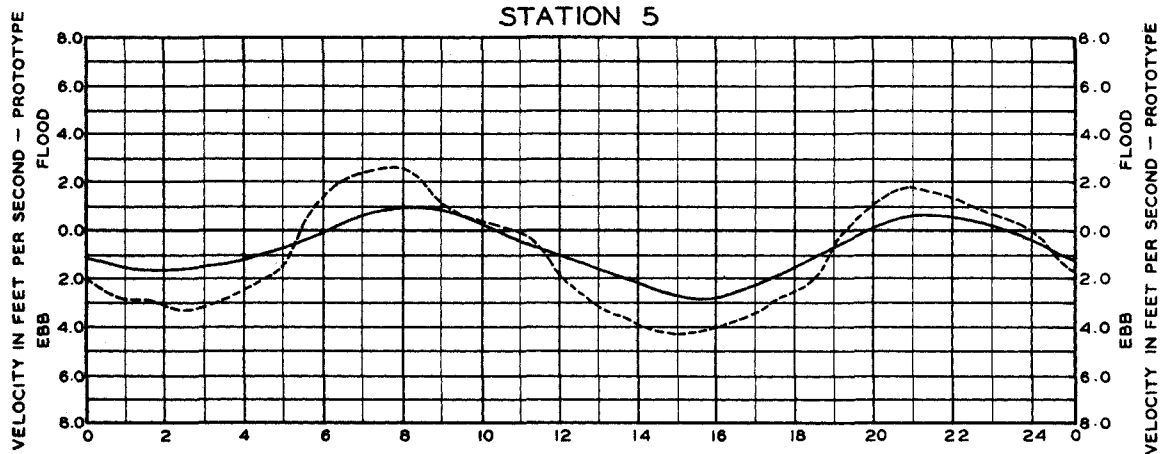
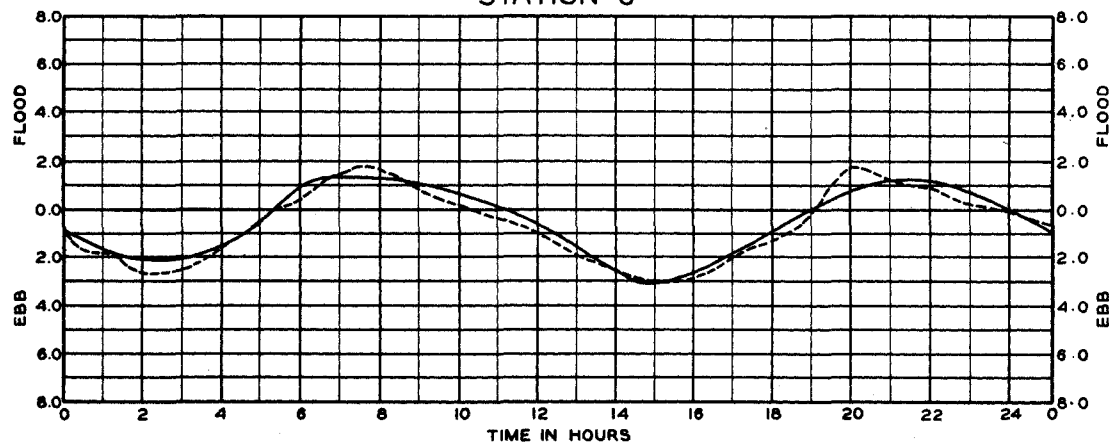
VELOCITY CURVES PLAN 2 STATIONS 4 TO 6

STATION 4

STATION 5

STATION 6
